Manhole Inspection Summary

Manhole # S350__030MH

Insp Date: **1/23/08 4:29 PM**

Location Address: **e churchill st**

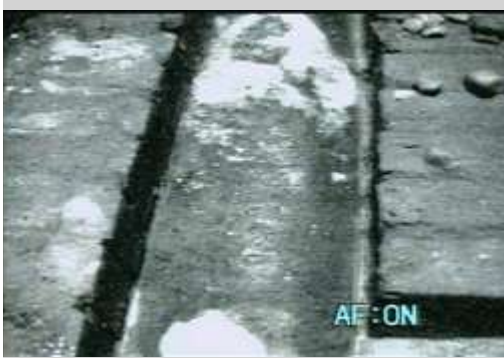
Defect 2

channel debris

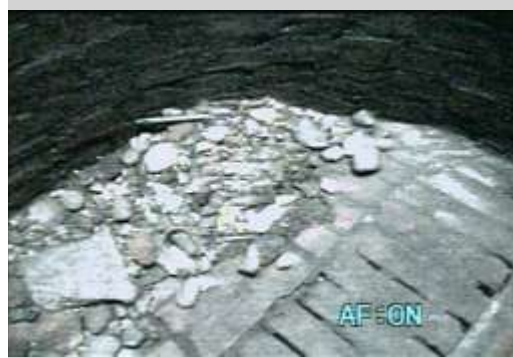
Defect 1

bench debris

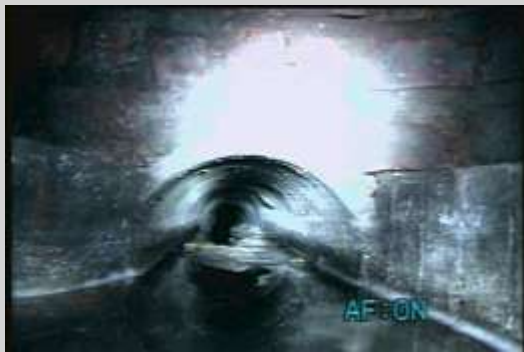
12 O'Clock Outflow

8 in. Circular Gravity Sewer
Pipe Out @ 12 O'Clock

Pipe Material: **Clay** ☐ Pipe Lined

Invert Depth: 11.30 (ft.) Flow Characteristics: **Slow**

Deposits: ☒ None ☐ Mud ☐ Sludge ☐ Debris ☐ Grease

Infiltration: **None** Pipe Seal Cond: **Unknown**

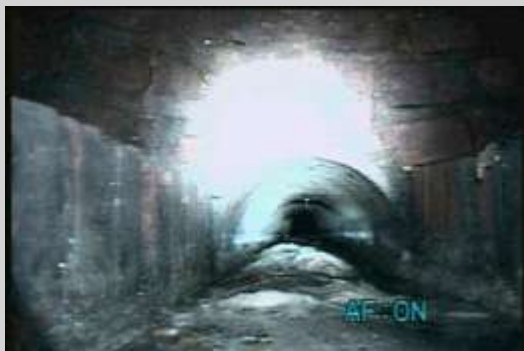
6 O'Clock Inflow

8 in. Circular Gravity Sewer
Pipe In @ 6 O'Clock

Pipe Material: **Clay** ☐ Pipe Lined

Invert Depth: 11.00 (ft.) Flow Characteristics: **Slow**

Deposits: ☒ None ☐ Mud ☐ Sludge ☐ Debris ☐ Grease

Infiltration: **None** Pipe Seal Cond: **Unknown**

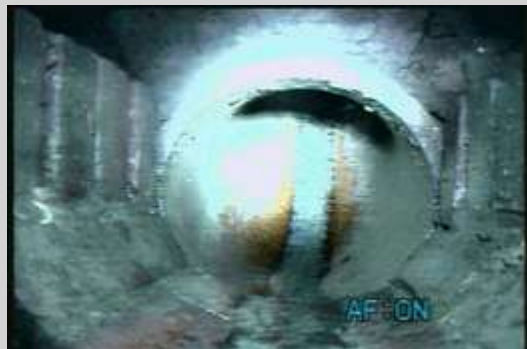
9 O'Clock Inflow

8 in. Circular Gravity Sewer
Pipe In @ 9 O'Clock

Pipe Material: **Clay** ☐ Pipe Lined

Invert Depth: **11.10** (ft.) Flow Characteristics: **Slow**

Deposits: ☒ None ☐ Mud ☐ Sludge ☐ Debris ☐ Grease

Infiltration: **None** Pipe Seal Cond: **Unknown**
